Massachusetts State Police investigating bridge collision

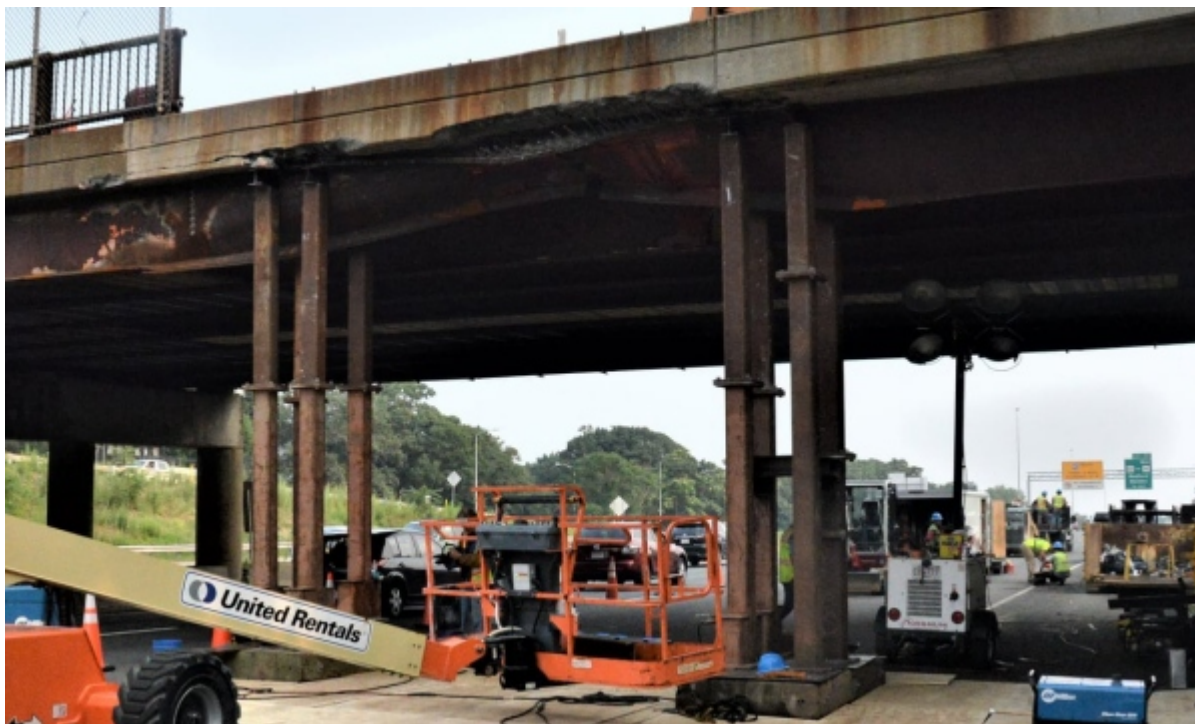
Massachusetts State Police photo.

The metal tank being hauled came into contact with the first and second structural beams of the underside of the bridge; the first beam was split in two and the second was bowed from the impact. The tank and the trailer sustained significant damage. The tractor appeared to sustain minor damage. The cargo and damaged trailer pieces were towed from the scene by Stephens Towing.
